St JAMES Church HAYDOCK.
SOUTH AISLE

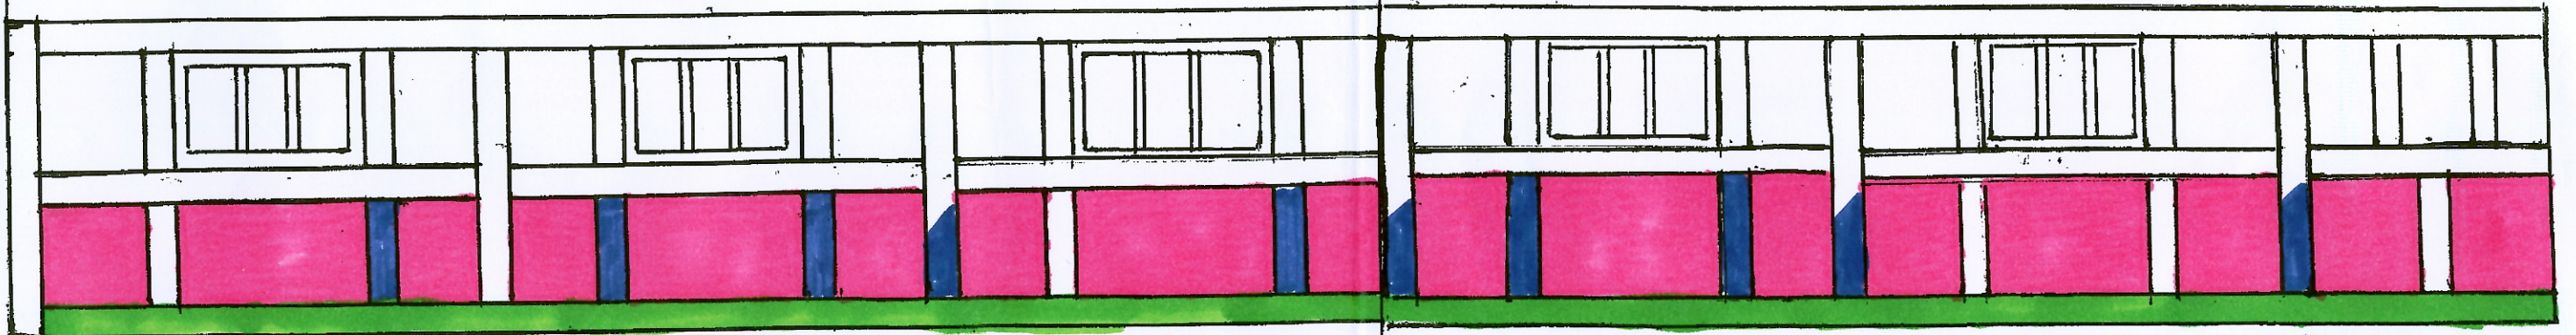
Repair to Intermediate Post
-

Spliced Repair to Main Post
-

New Sole Plate
-

Rebuild Brick Panel
